## Seahorse Maritime Consultants

**Case:- #0143TR**

### **CONDITION SURVEY**

<b>Name of Vessel:-</b>	<b>S.V. Bewildered</b>
<b>Registration Number:-</b>	<b>SSR 62623</b>
<b>Port of Registry:-</b>	<b>N/A under SSR</b>
<b>Type of Vessel:-</b>	<b>Aux/Sail, Cutter</b>
<b>Builder/Yard:-</b>	<b>Cape Yachts, Hong Kong</b>
<b>Construction:-</b>	<b>GRP</b>
<b>Place &amp; Year Built:-</b>	<b>Hong Kong, 1975</b>
<b>Length:- 13.25m    Beam:- 3.87m    Draft:- 2m</b>	
<b>Displacement:- 11.5 tons    Ballast:- 5.6 tons</b>

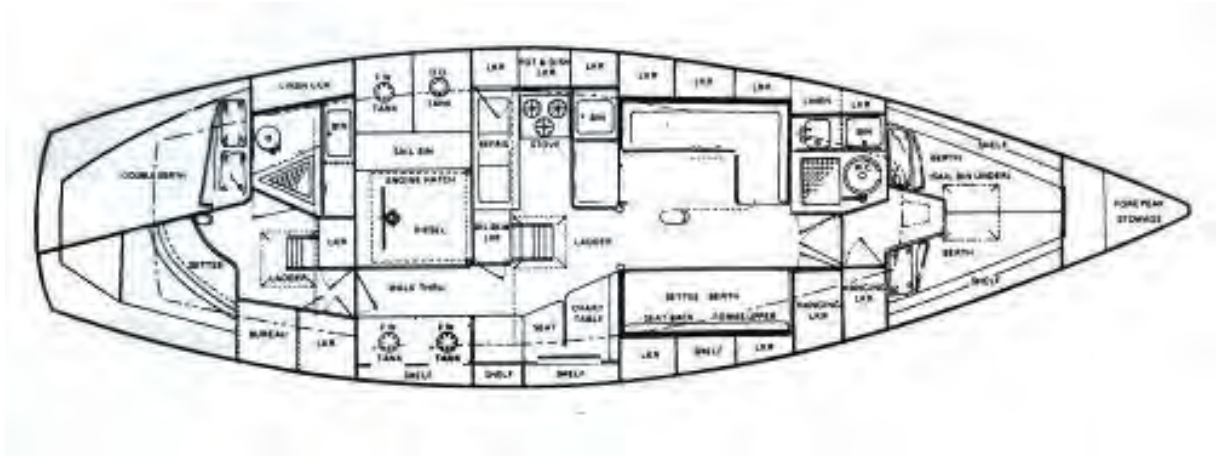
The layout above is taken from the original sales brochure and is mostly accurate but there are small modifications to the arrangement of storage lockers, re-arranged afthead, and the removal of the aftcabin companion stairs replaced by Teak swimladder stowage.
